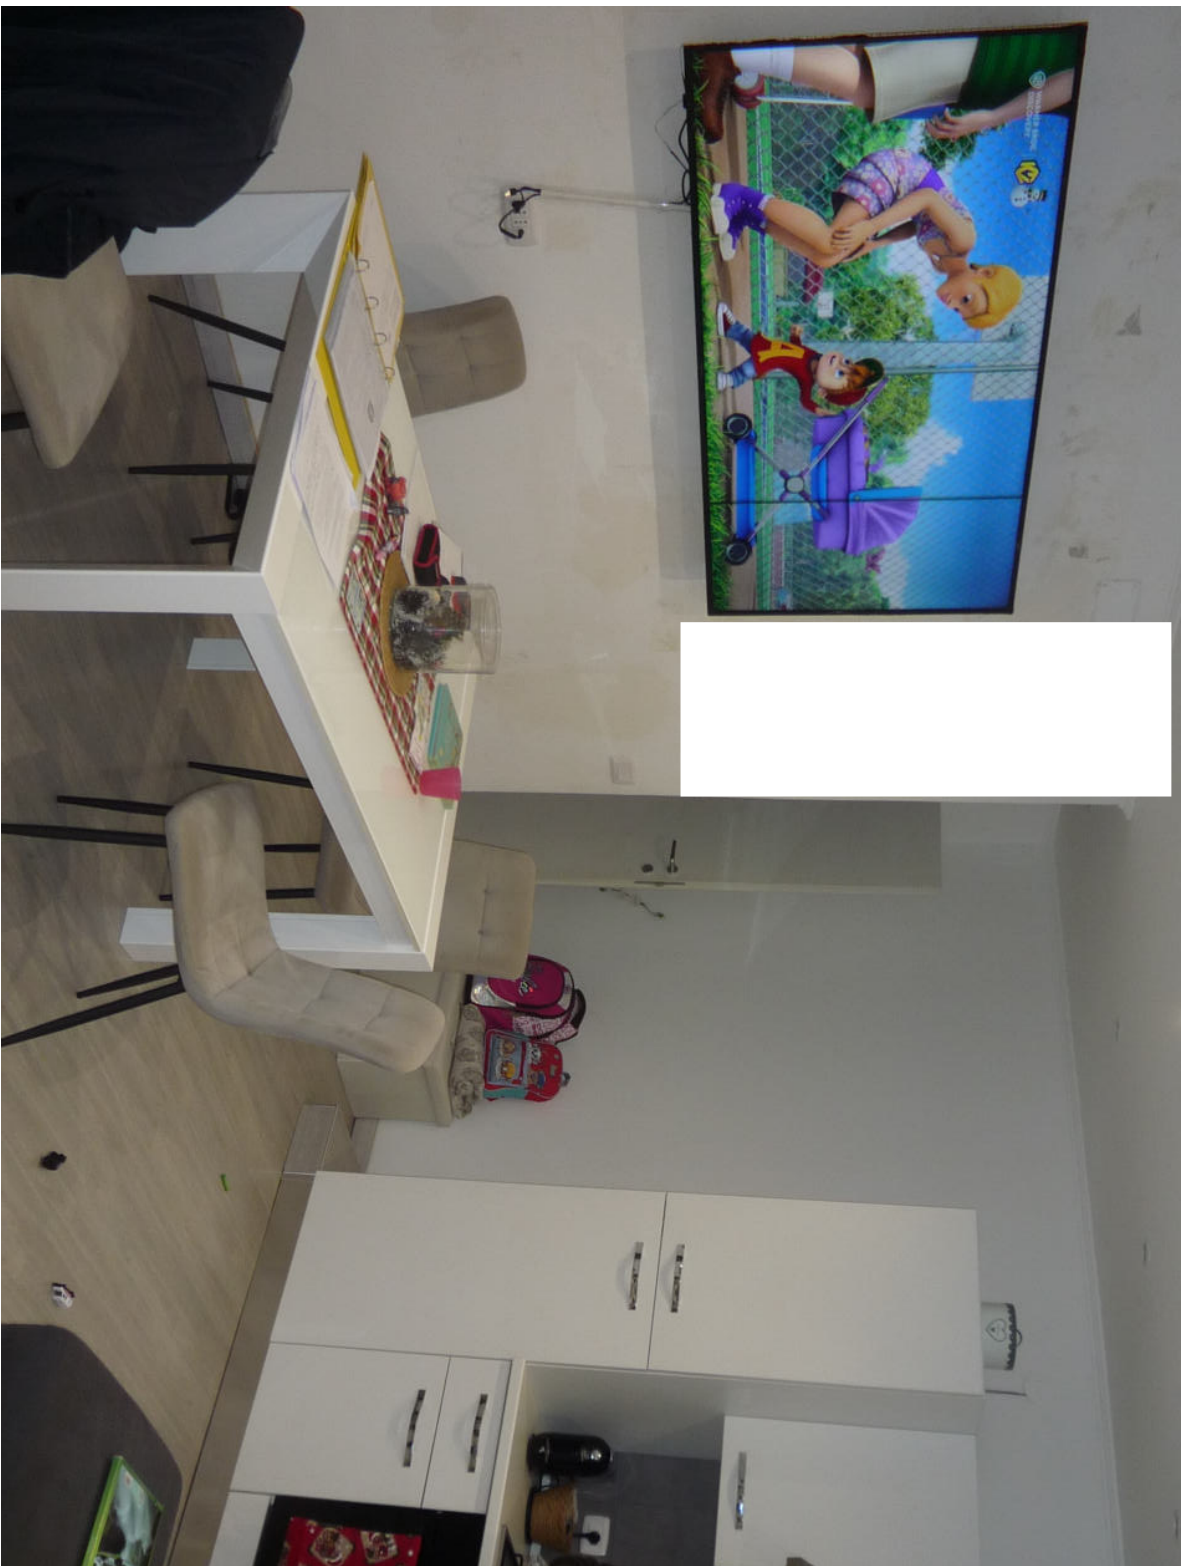
TRAMEZZO DIVISORIO EX ANGOLO COTTURA  
RIMASTO ALLA SOLA DEMOLIZIONE

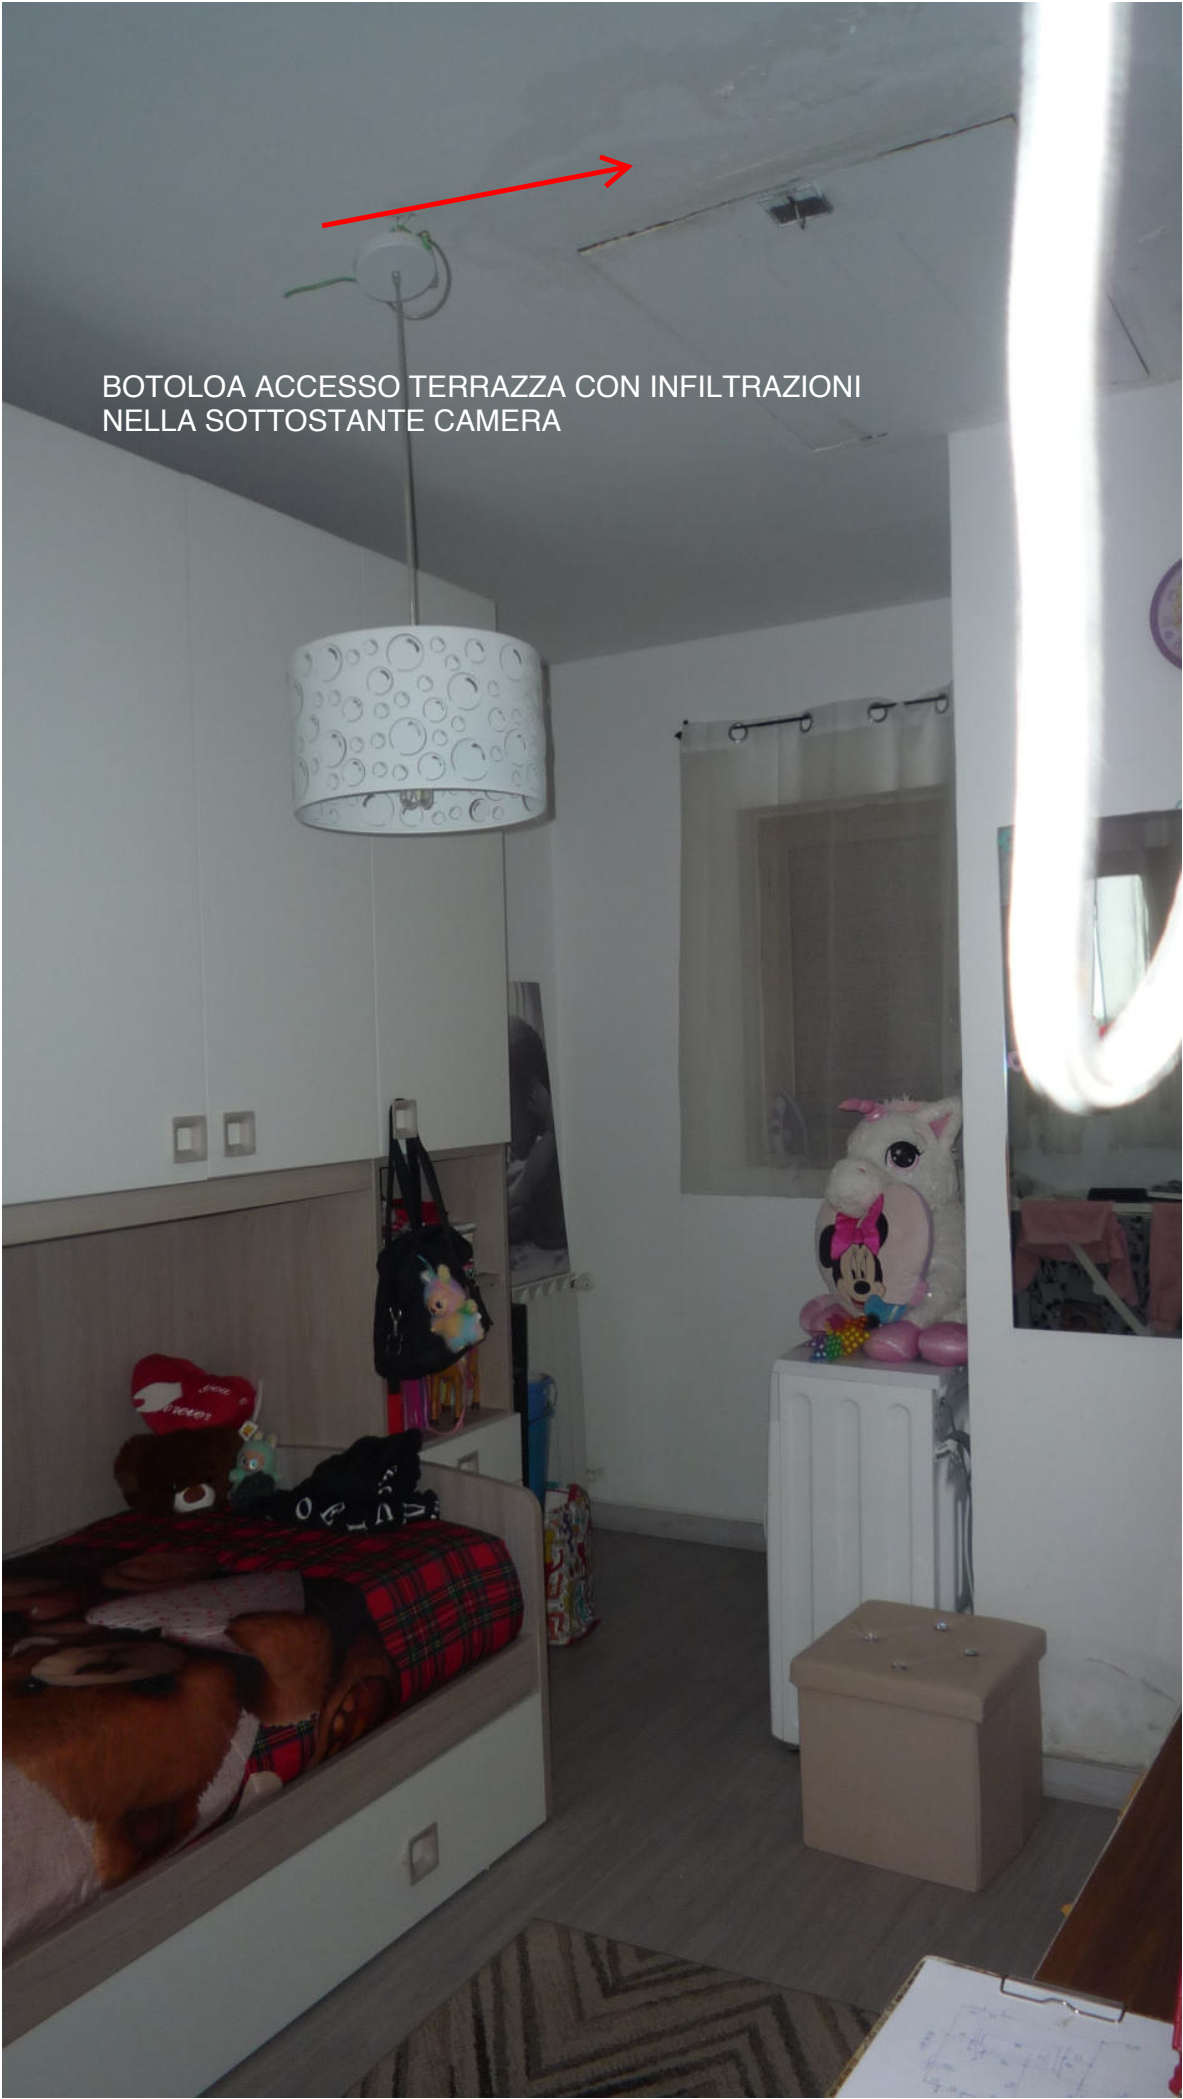
A photograph of a child's bedroom. A red arrow points to a hole in the ceiling. The room contains a bed with a red and black plaid blanket, a white wardrobe, a white lampshade with a bubble pattern, a window with a grey curtain, a white dresser with a Minnie Mouse plush toy, and a brown ottoman. A clipboard with a floor plan is visible in the bottom right corner.

BOTOLOA ACCESSO TERRAZZA CON INFILTRAZIONI  
NELLA SOTTOSTANTE CAMERA

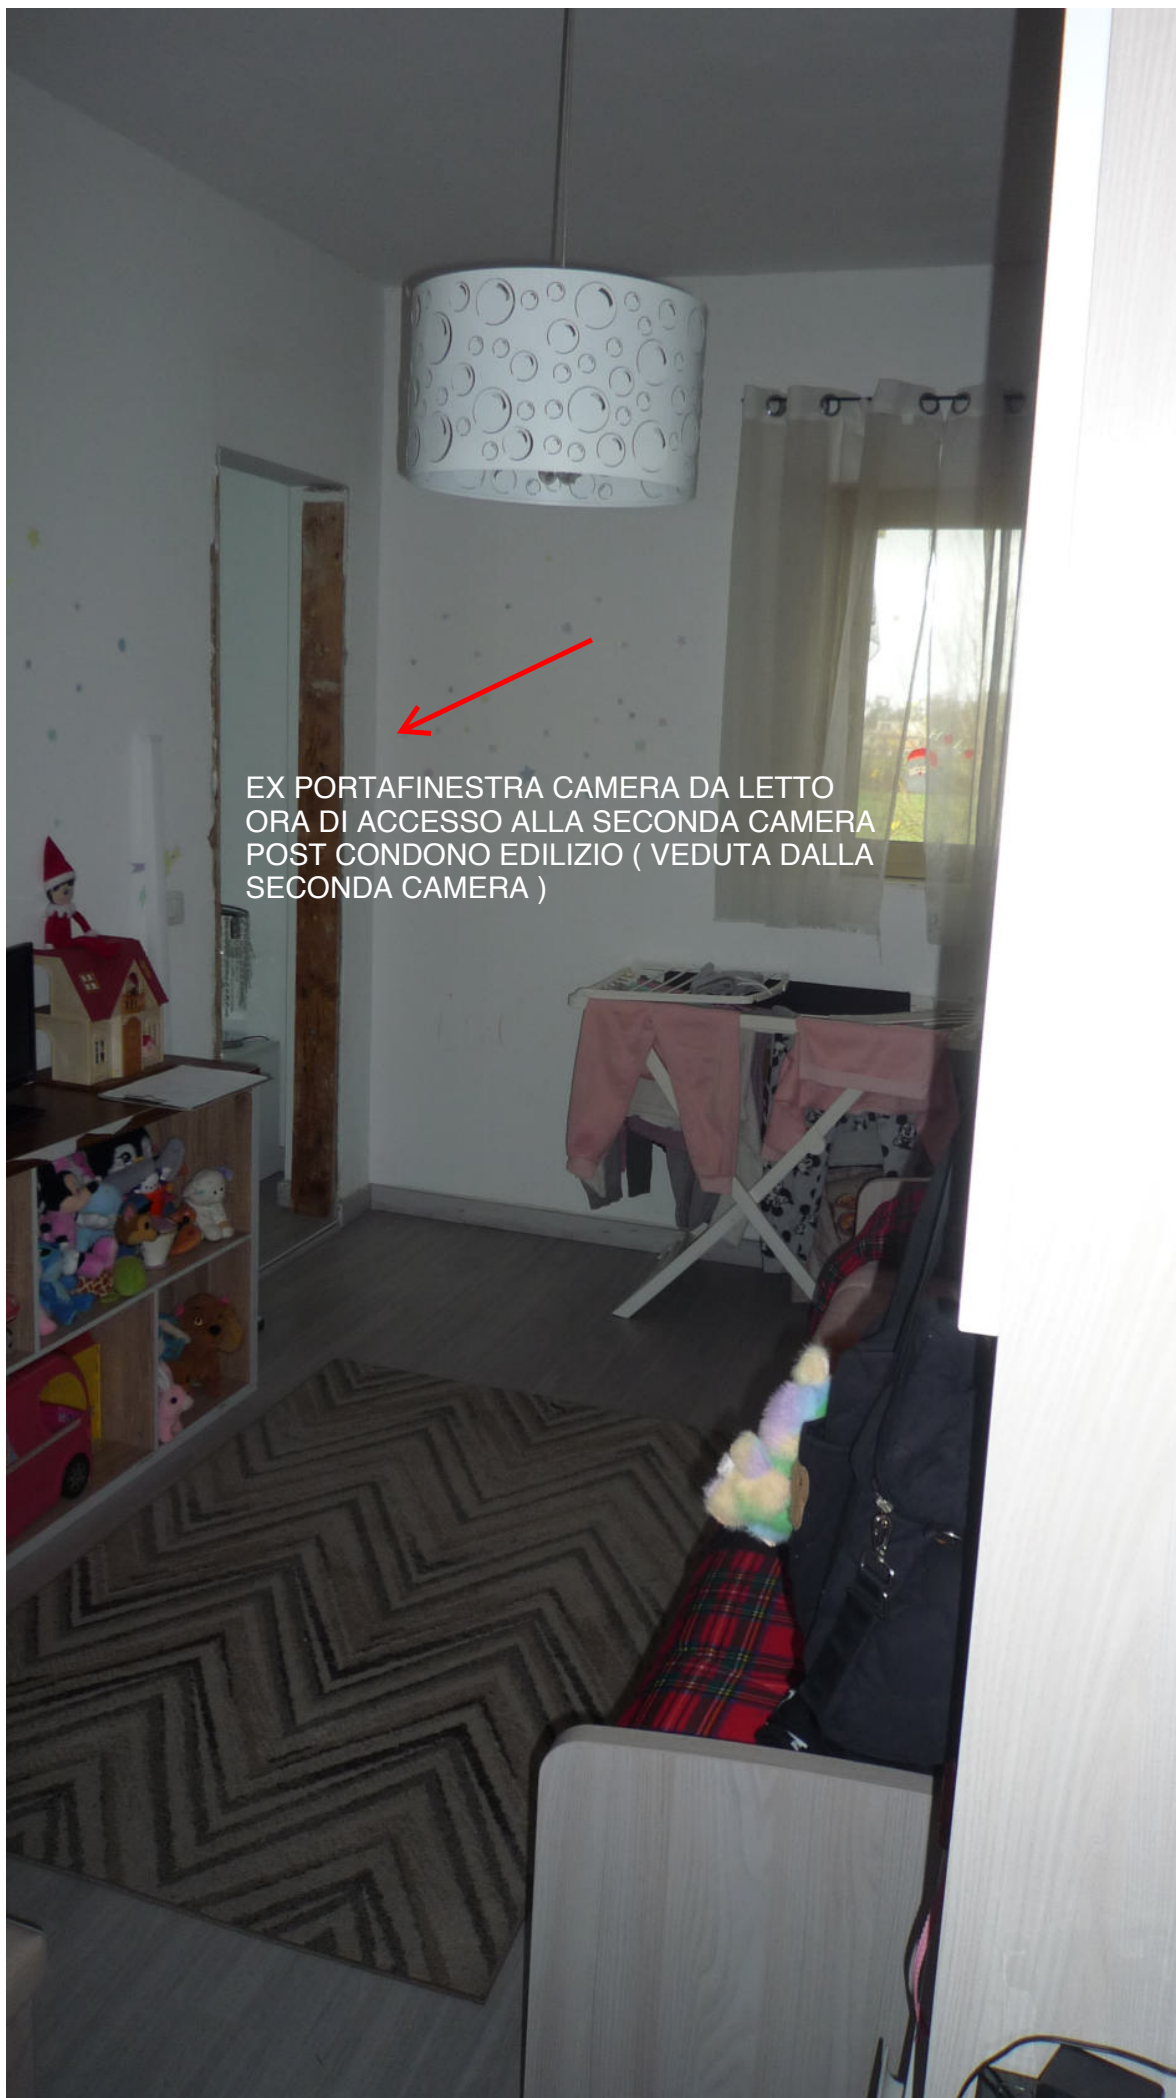
EX PORTAFINESTRA CAMERA DA LETTO  
ORA DI ACCESSO ALLA SECONDA CAMERA  
POST CONDONO EDILIZIO ( VEDUTA DALLA  
SECONDA CAMERA )

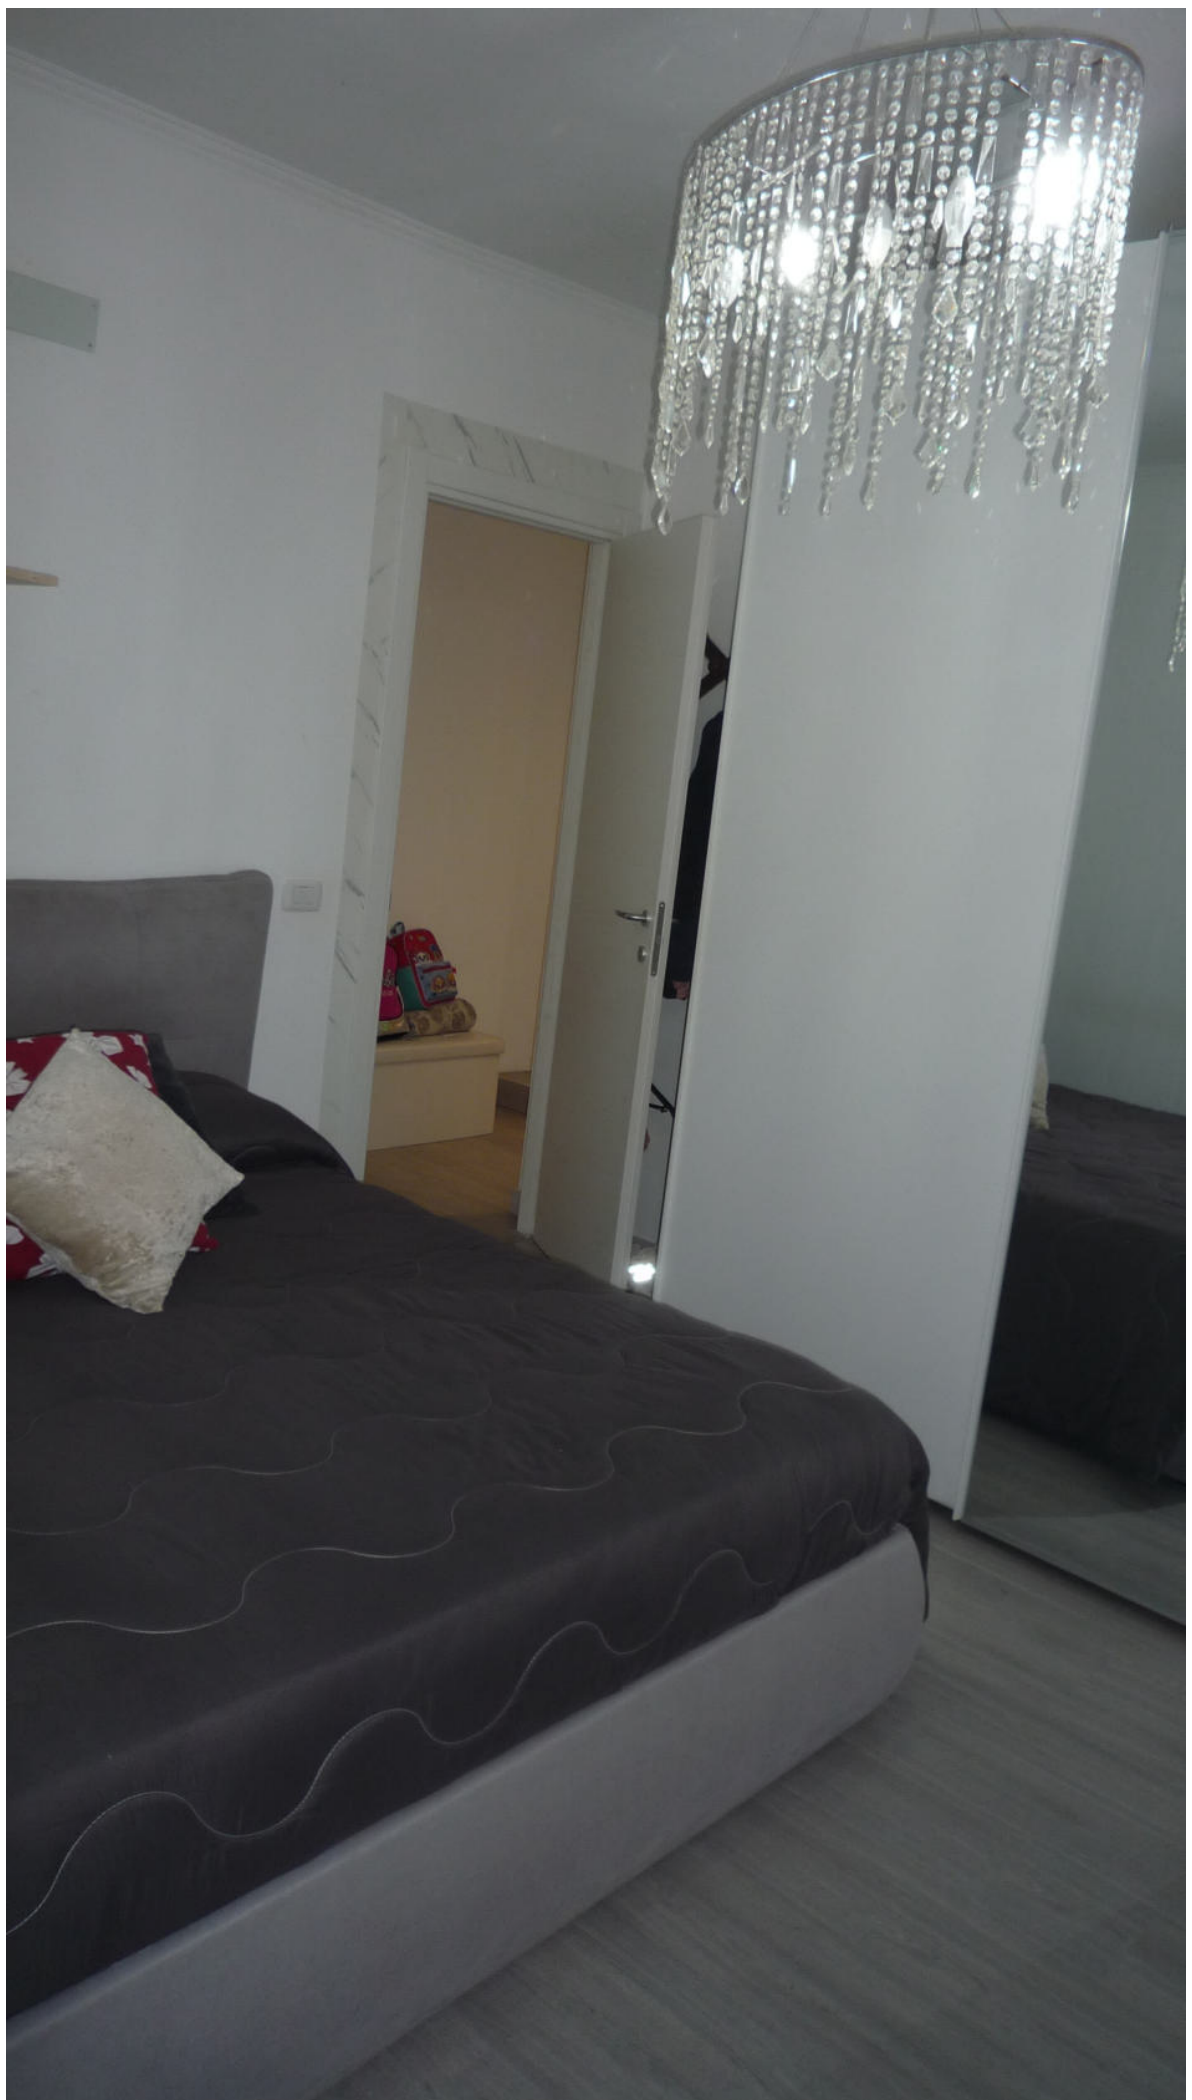
EX PORTAFINESTRA CAMERA DA LETTO  
ORA DI ACCESSO ALLA SECONDA CAMERA  
POST CONDONO EDILIZIO ( VEDUTA DALLA  
PRIMA CAMERA )  
ALLO STATO ATTUALE LA PRIMA CAMERA DA  
LETTO NON DISPOPNE DI AFFACCIO E  
RICAMBIO D'ARIA NATURALE

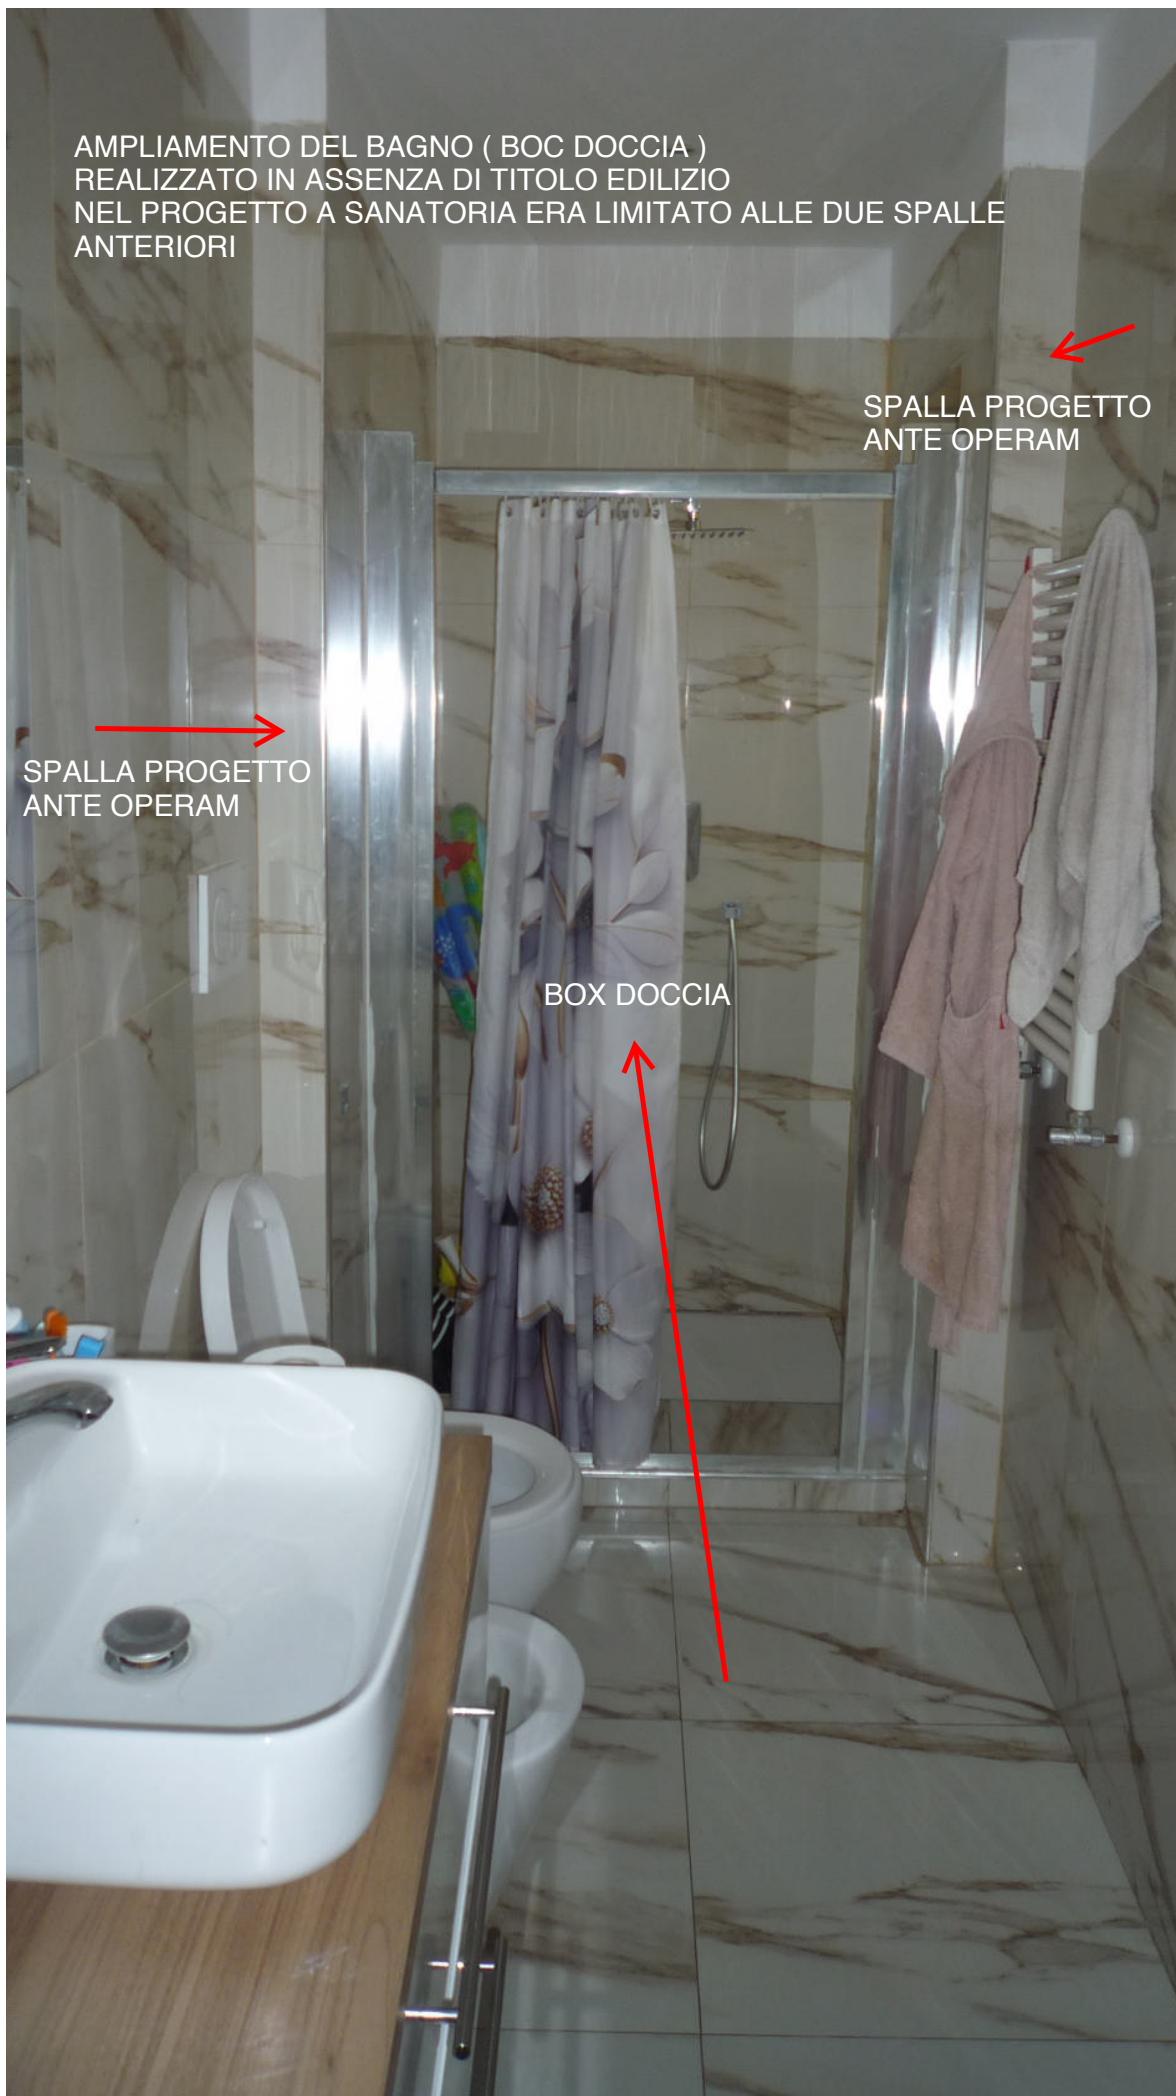
AMPLIAMENTO DEL BAGNO ( BOC DOCCIA )  
REALIZZATO IN ASSENZA DI TITOLO EDILIZIO  
NEL PROGETTO A SANATORIA ERA LIMITATO ALLE DUE SPALLE  
ANTERIORI

SPALLA PROGETTO  
ANTE OPERAM

BOX DOCCIA

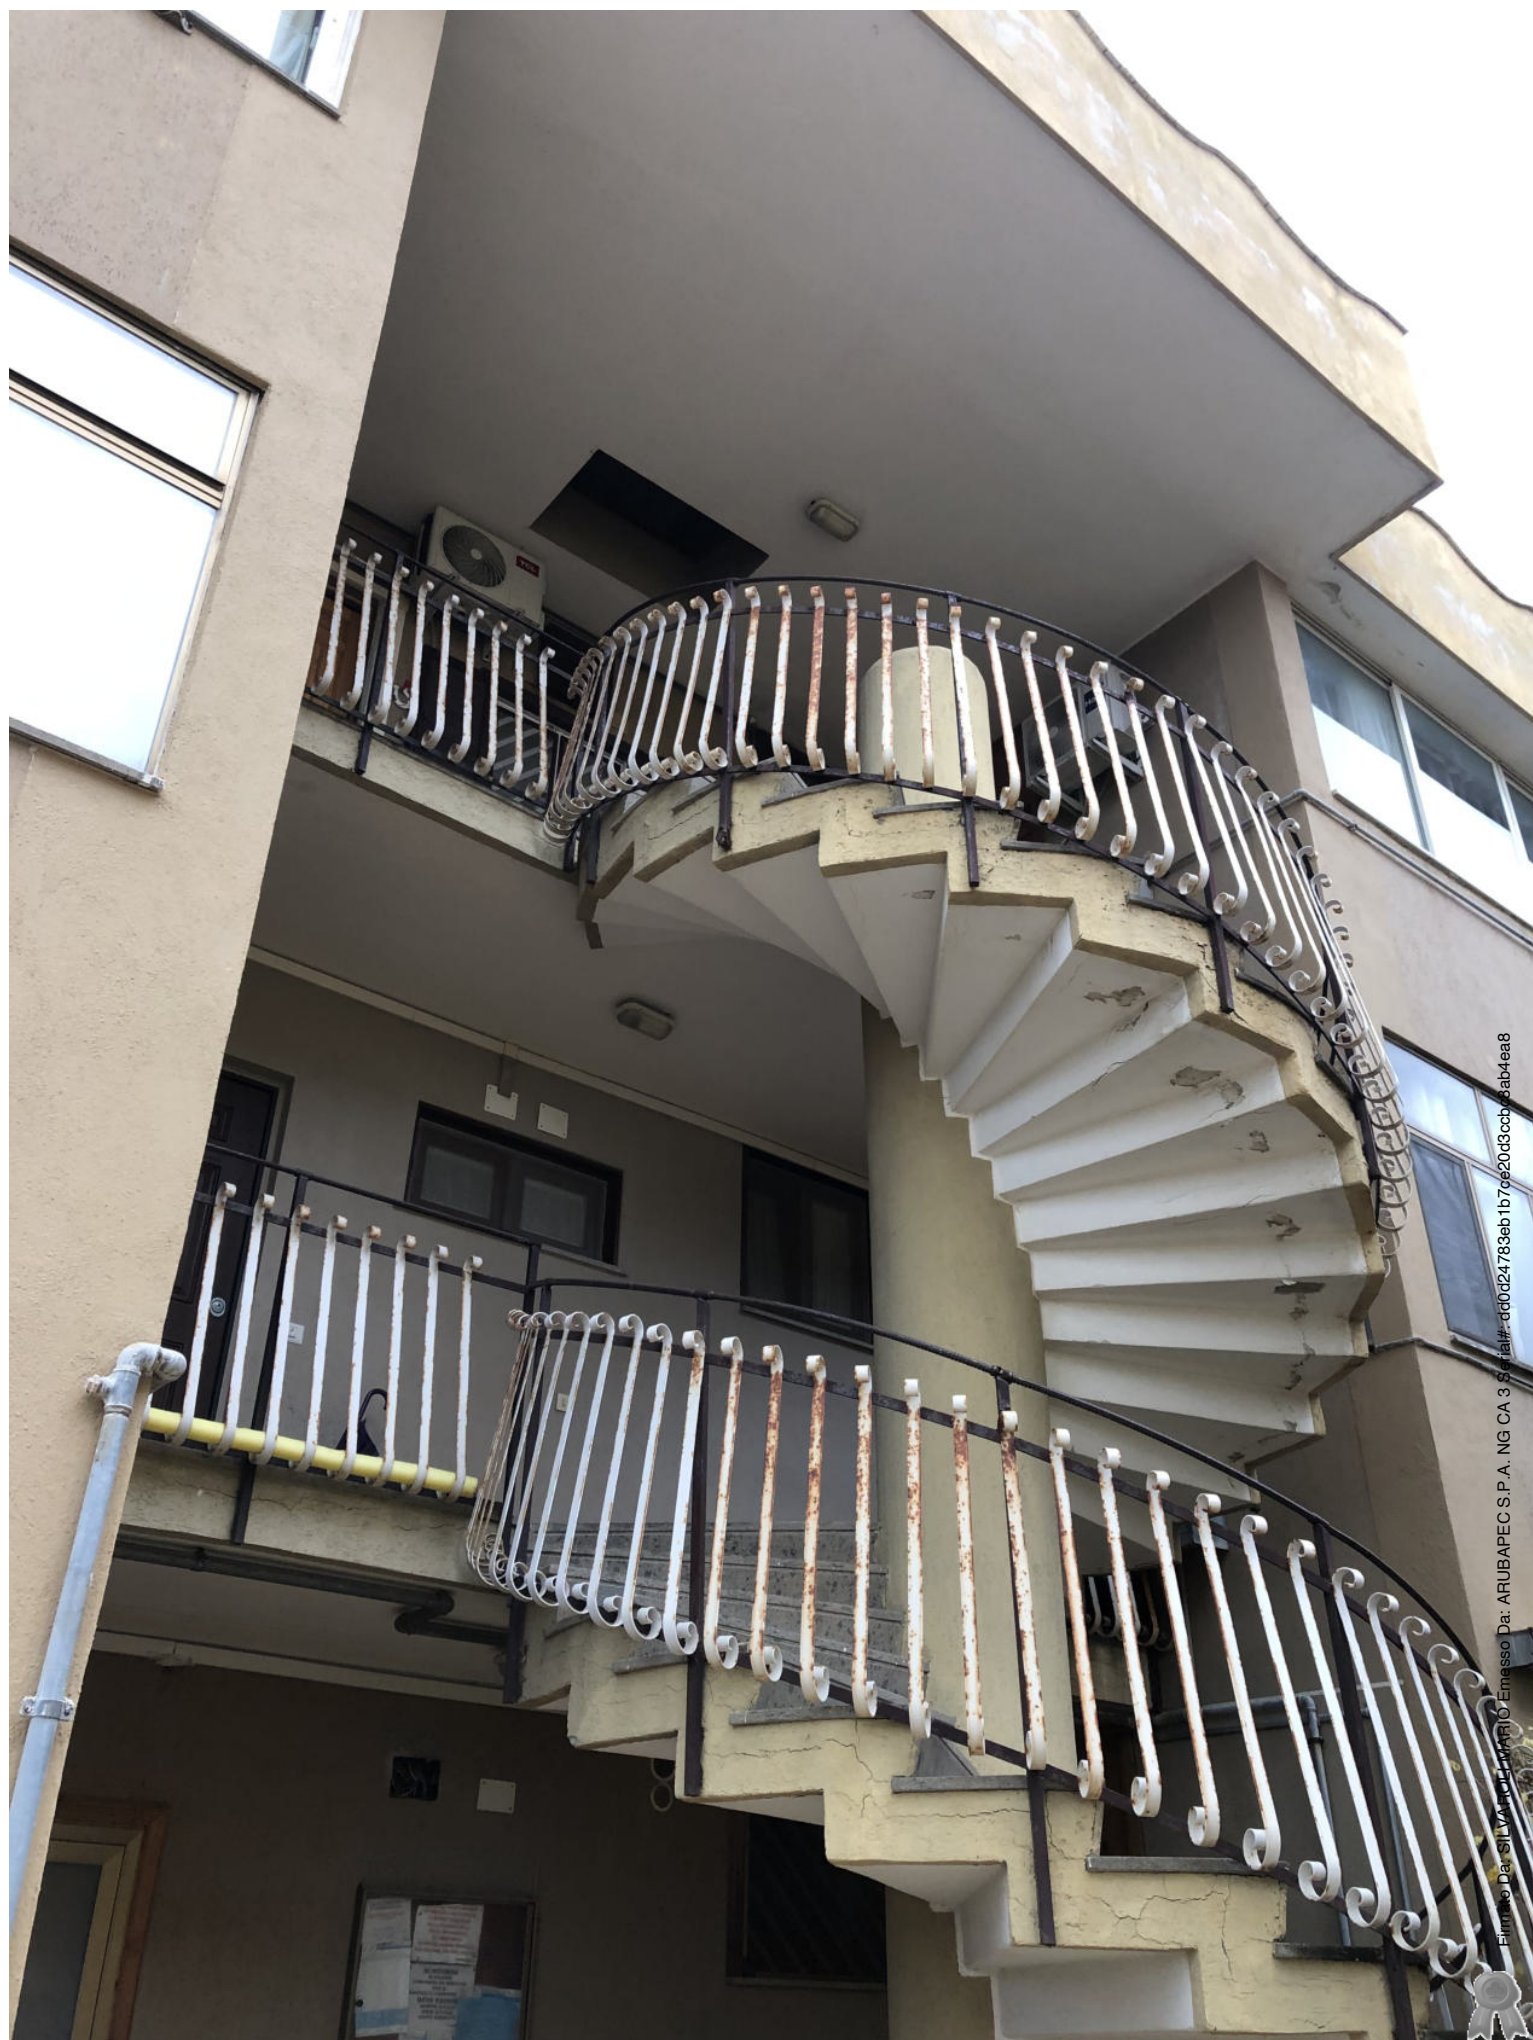
SOLO ACQUA CALDA SANITARIA  
SENZA RISCALDAMENTO
